# EVALUATING CONCRETE BRIDGE DECK PERFORMANCE

## *Interim Project Report*

While planning the replacement of three bridges on Highway 243 north of Saco, Montana, bridge engineers at the Montana Department of Transportation (MDT) recognized and seized a unique opportunity to evaluate different deck designs built by the same contractor and subsequently exposed to the same environmental and vehicular conditions. Thus, variability in test articles and conditions between test sites typically encountered in large-scale field investigations was minimized in this situation. The primary focus of this research project has been to compare the performance of three different bridge deck designs.

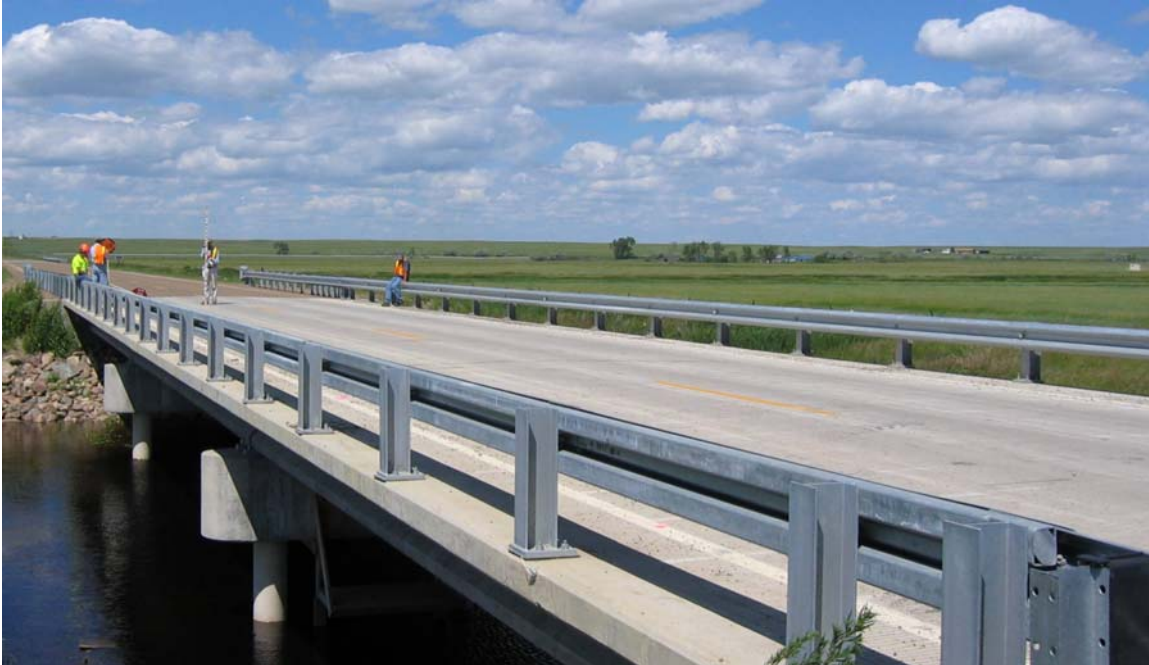
**Figure 1: Completed Saco Bridge**

The concrete was placed in the HPC deck on May 28, 2003; in the Empirical deck on June 3, 2003; and in the Conventional deck on June 5, 2003. Concrete samples were collected from several trucks in the instrumented section of the bridges. Over the next month, the bridges were allowed to cure, the deck forms were removed, the saw-cuts were made over the south bents, the decks were grooved, the guardrail was installed, and the bridge approaches were paved. Figure 1

shows one of the finished Saco bridges. The first live load tests were conducted in late July 2003, as well as the benchmark durability tests (i.e., half-cell tests and carbonation tests). Additionally, the first topographic survey of the bridge decks was conducted. All three bridges were then opened to public use in early August 2003.

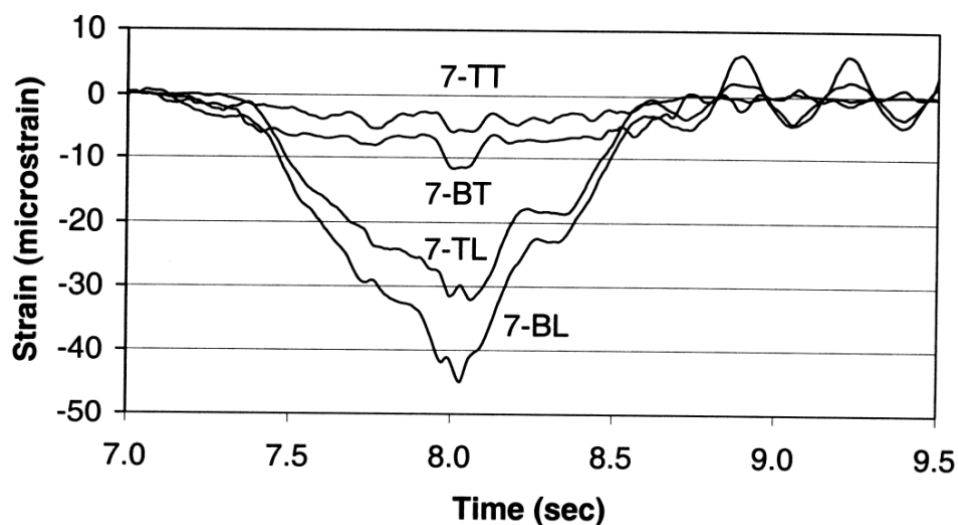
Stallings and Porter (2002) performed live load tests on the Uphapee Creek Bridge in Alabama, in which some measurements of the deck response were made. This bridge deck was constructed using a high performance concrete (HPC) mix design. Comparisons of test results with AASHTO predictions were of greatest interest to the authors. Although deck strains recorded from strain gages attached to transverse reinforcement were measured and reported, little comment was offered with regard to their meaning. Typical deck strain results reported by Stallings and Porter (2002) are shown in Figure 2. Internal deck strains recorded from strain gages located at the longitudinal midspan and transversely between two girders are shown. The abbreviations “TT” and “BT” refer to top transverse and bottom transverse gages, respectively, and, “TL” and “BL” refer to top longitudinal and bottom longitudinal gages, respectively.

**Figure 2: Reported Deck Strains at Midspan (from Stallings and Porter, 2002)**

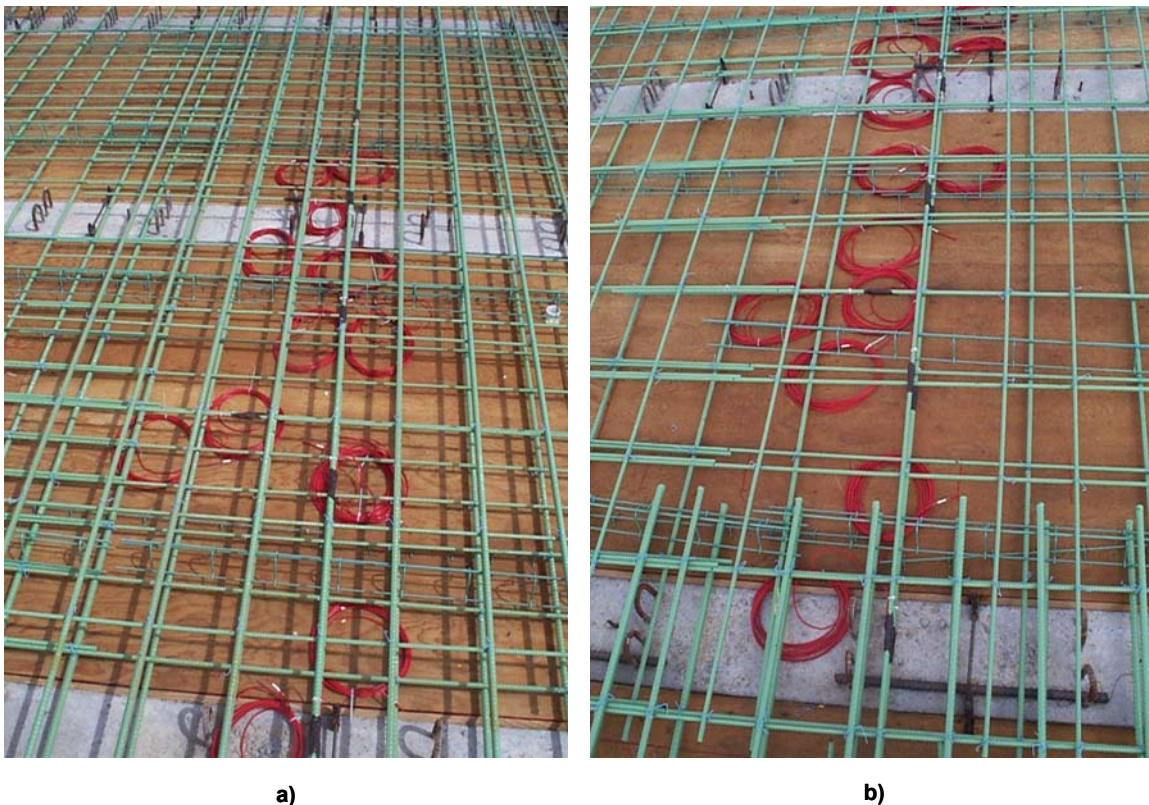
each direction in the top mat, and  $5.7 \text{ cm}^2/\text{meter}$  ( $0.27 \text{ in}^2/\text{ft}$ ) in each direction in the bottom mat. The reason for the increased amount of steel in the bottom mat is for better crack control in the positive bending regions of the slab. Comparatively, in the construction drawings for the decks constructed as part of this research project, the Conventional and HPC decks require 3679 kg more steel than the empirical deck. Figure 7 demonstrates the difference in the density of the reinforcement between the two deck designs, taken at the same place in the deck. Reducing the amount of steel in the empirical deck, especially in the top layer, decreases the opportunity for, and the affects of reinforcement deterioration.

**Figure 7: Example Reinforcement Densities of the Conventional and HPC Decks (a), and the Empirical Deck (b)**

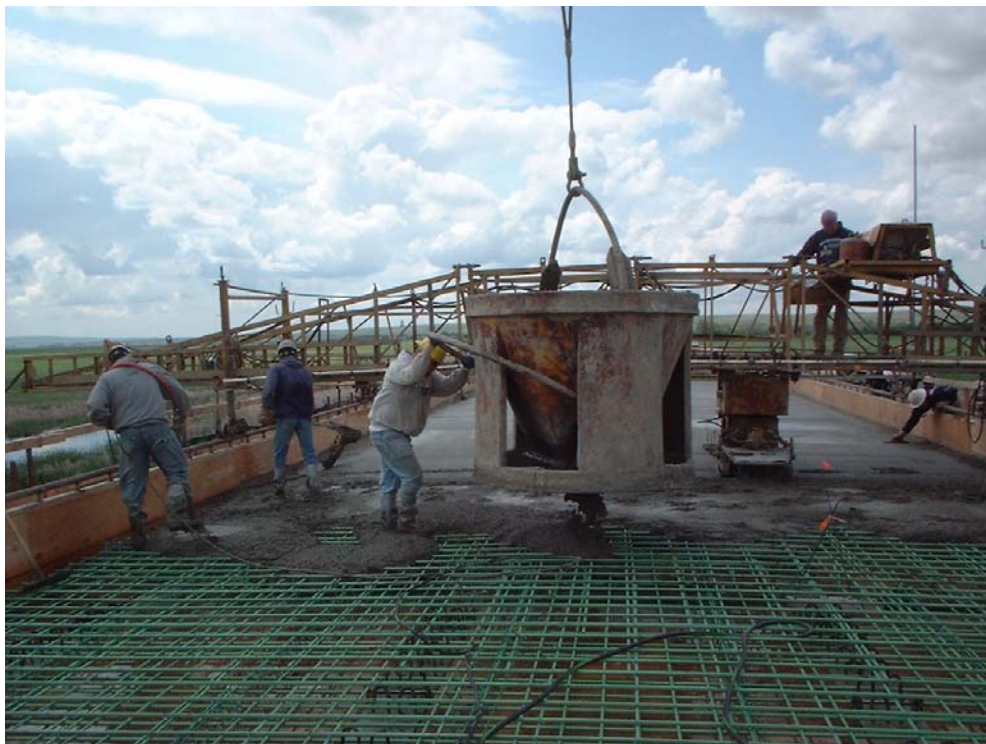
**Figure 8: Placing the Deck Concrete**

Concrete was poured into the decks using a two-yard bucket and a crane, and was leveled using an automatic screed (Figure 8). During construction of the bridge decks, MDT performed air content tests, slump tests, and collected test specimens from selected trucks on each bridge to make concrete test cylinders. Average results from slump and air content tests are provided in Table 1, and the detailed results from all tests are summarized in Appendix A. In addition, the Western Transportation Institute (WTI) collected concrete test specimens from a representative portion of the concrete used to cast the instrumented section of each deck. Sufficient samples

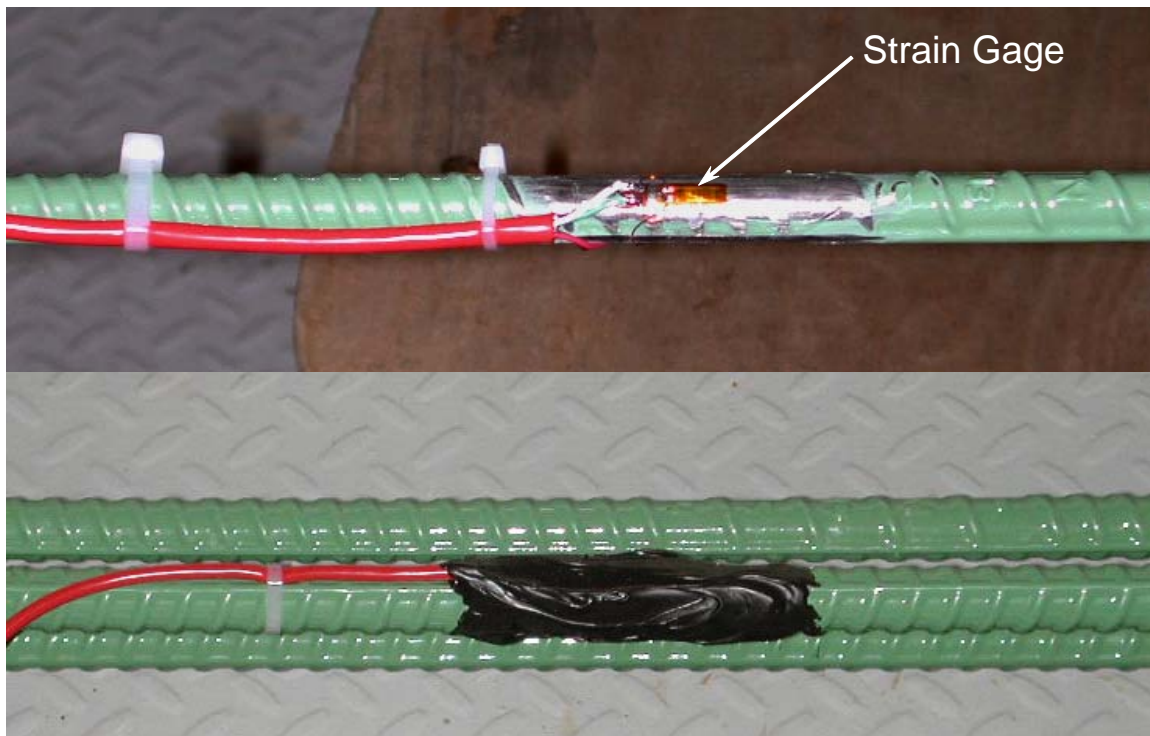
A two-part polysulfide liquid polymer compound (Micro-Measurements M-COAT J) was used to environmentally protect the strain gages from damage during and after construction. This tough, flexible, black coating was mixed and applied over the strain gaged area in the lab and allowed to dry overnight before moving. M-COAT J provides good protection against oil, grease, most acids and alkalis, and most solvents. Figure 15 shows a strain gage bonded to the reinforcement before and after the environmental protection was installed.

**Figure 15: Strain Gage Bonded to the Reinforcement before (Top) and after (Bottom) Environmental Protection**

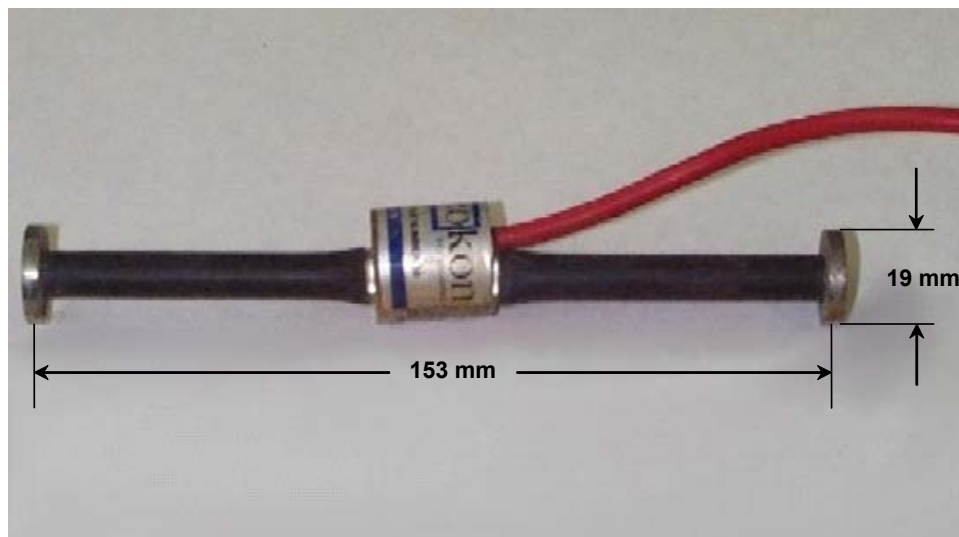
The 20 vibrating wire strain gages that were embedded in the bridge deck concrete for long term monitoring were purchased from Geokon (Model VCE-4200). This standard model, shown in Figure 16, has a 153 mm (6 in.) gage length, 3000 microstrain range, and 1 microstrain sensitivity. They are designed to be embedded directly in concrete and are typically used to monitor long-term strain and temperature in structures such as foundations, piles, bridges, dams, containment vessels, and tunnel liners.

**Figure 16: Vibrating Wire Strain Gage (VCE-4200)**

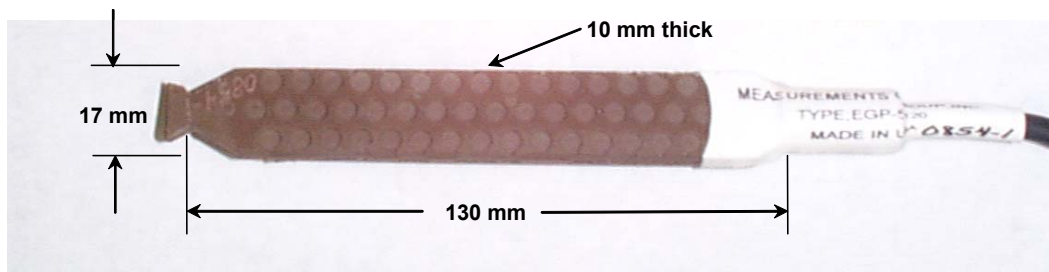
Nine concrete embedment gages, specially made to measure strains inside concrete structures, were used in each of the bridge decks. These gages (EGP-5-350), shown in Figure 18, were purchased from Micro-Measurements Group, Inc. Each embedment gage contains a single 350 ohm bonded-foil resistance strain gage (functionally similar to the ones described earlier). The sensing grid has an active gage length of 100 mm (4 in.) and is self-temperature-compensated to minimize thermal output when installed in concrete structures. The gage is set in a proprietary polymer body to protect them from corrosion, moisture and mechanical damage during construction and use. The outer body has a length of 130 mm (5 in.) and is dimpled to ensure proper adherence to the surrounding concrete. Embedment strain gages utilize a  $\frac{1}{4}$  Wheatstone bridge (described later), since there is only a single resistance strain gage housed in the polymer body.

**Figure 18: Concrete Embedment Strain Gage (EGP-5-350)**

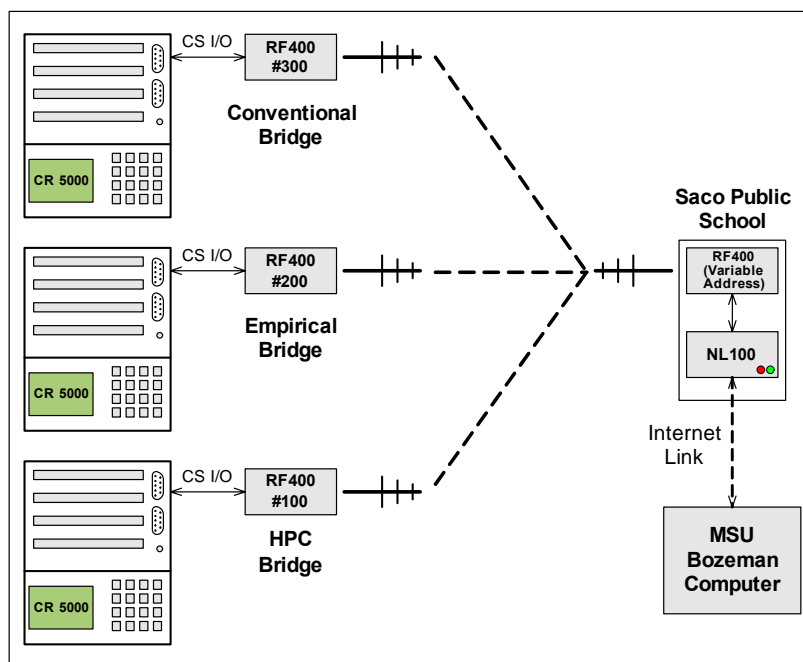
A spread spectrum radio (RF400) is used to transfer data to and from each of the bridges during the long term monitoring. Antennas connected to these radios communicate at 900 MHz to a single receiving antenna collocated with the weather station at the Saco Public School. Information is transferred from the school to WTI via the Internet. This communication path is illustrated in Figure 22. The antennas near the bridges are attached to a wooden pole along with the solar panel.

**Figure 22: Communication Path for Long Term Monitoring**

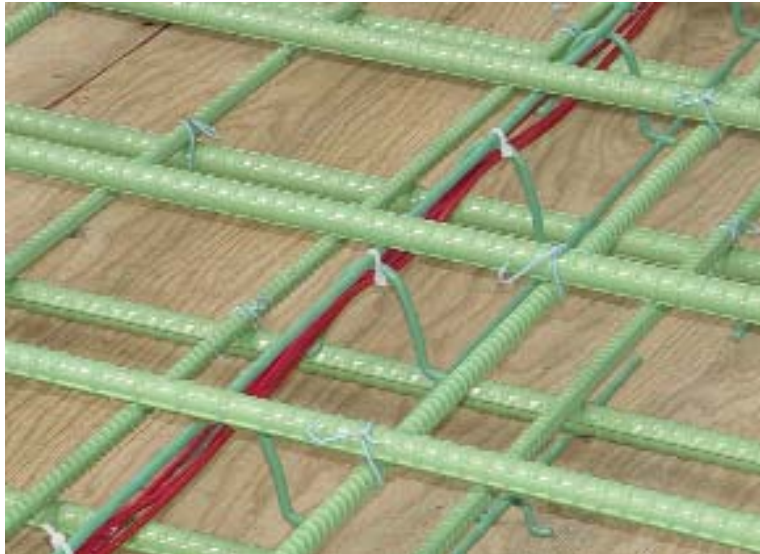
**Figure 29: Example of Cable Run**

strain gages were installed once the reinforcing cage for each bridge was complete. Lead wires were routed out through the bottom of the decks through predrilled exit ports. Cabling was bundled together and tied to the underside of reinforcing bars or to the chairs used to space the top mat of reinforcement from the bottom mat, as shown in Figure 29.

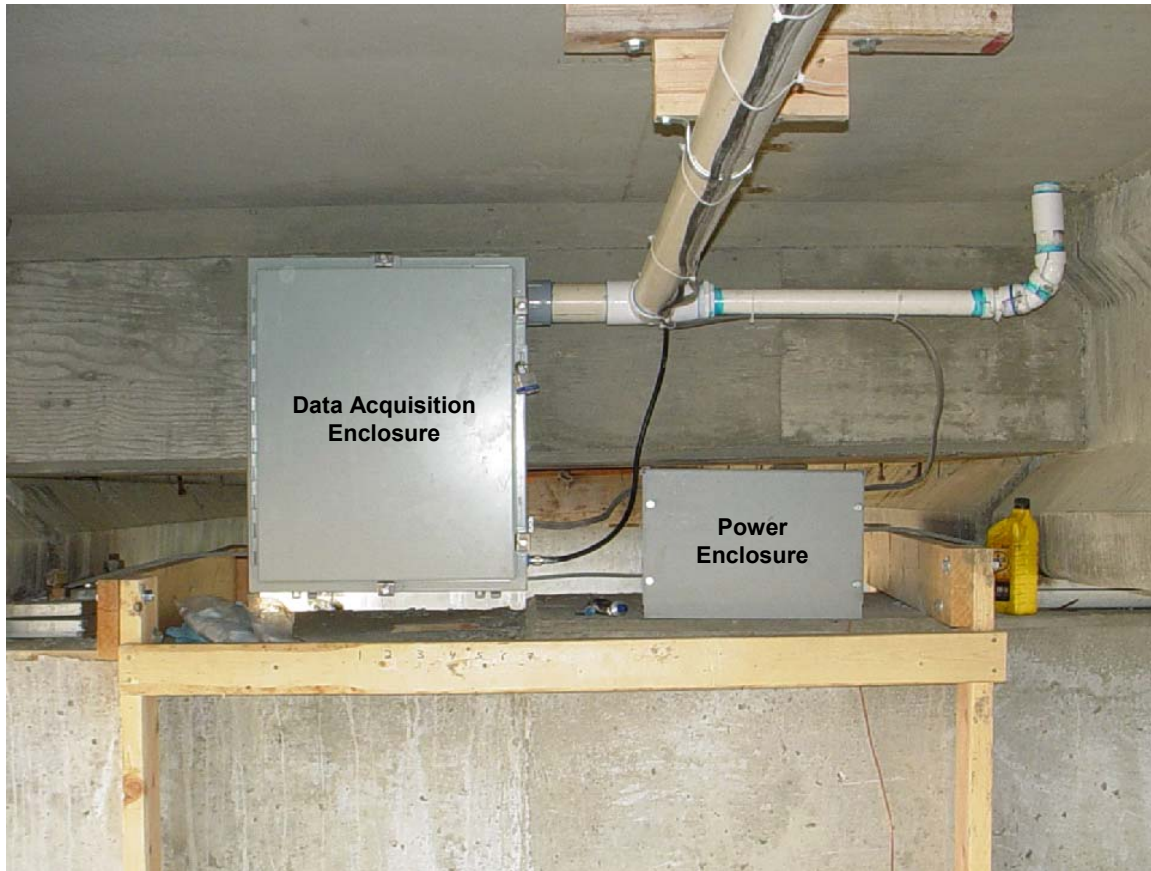
**Figure 30: Data Acquisition and Power Enclosure Arrangement under the Bridge Decks**

The data acquisition box for each deck was temporarily installed under the bridge near the south bent prior to placing the bridge deck concrete. The lead wires from the gages were connected to the data acquisition system after being routed through the exit ports in the deck forms. After the pour, the bottoms of the bridge decks were deformed, and the data acquisition and power enclosures were permanently mounted to the diaphragm and pile cap, respectively. All lead wires were then trimmed and permanently plumbed in PVC conduit between the exit

ports and the data acquisition boxes. The final arrangement of the data acquisition system and power enclosures with the plumbing in place is shown in Figure 30.

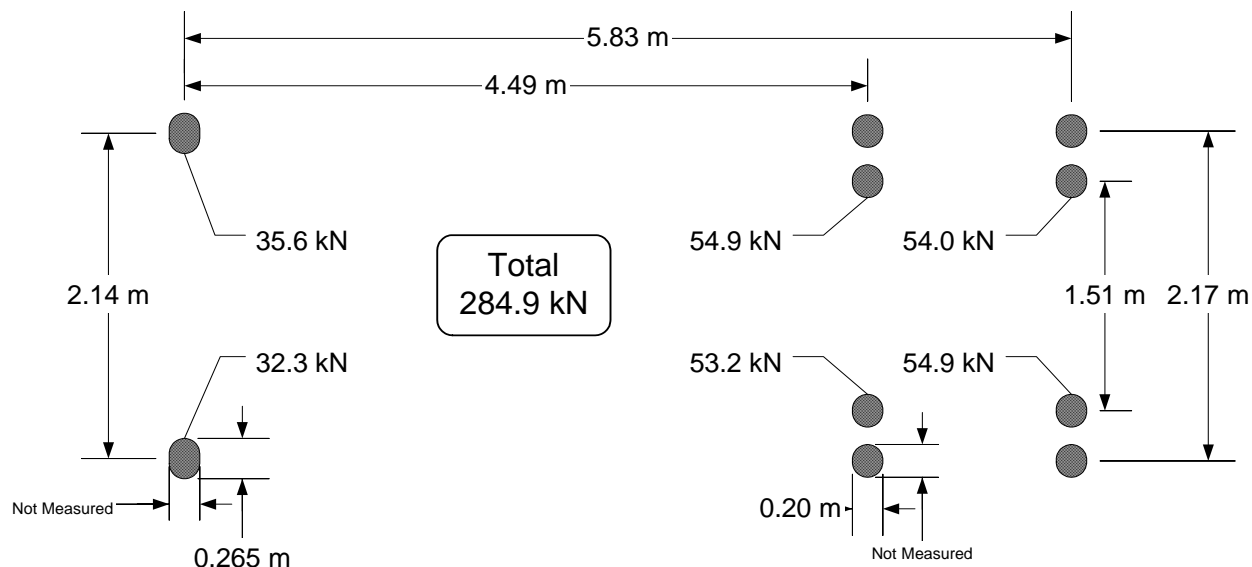
the proposed heavier load set (Yang and Myers, 2003; Stallings and Porter, 2003; Nassif et al., 2003). The weights and dimensions of the actual trucks used in the live-load experiments (a Sterling and a Volvo truck) are summarized in Figures 32 and 33, respectively. Figure 34 shows the Sterling truck which was used for all the single truck tests.

**Figure 32: Dimension and Weight of the Sterling 3-Axle Dump Truck Used during Live Load Tests**

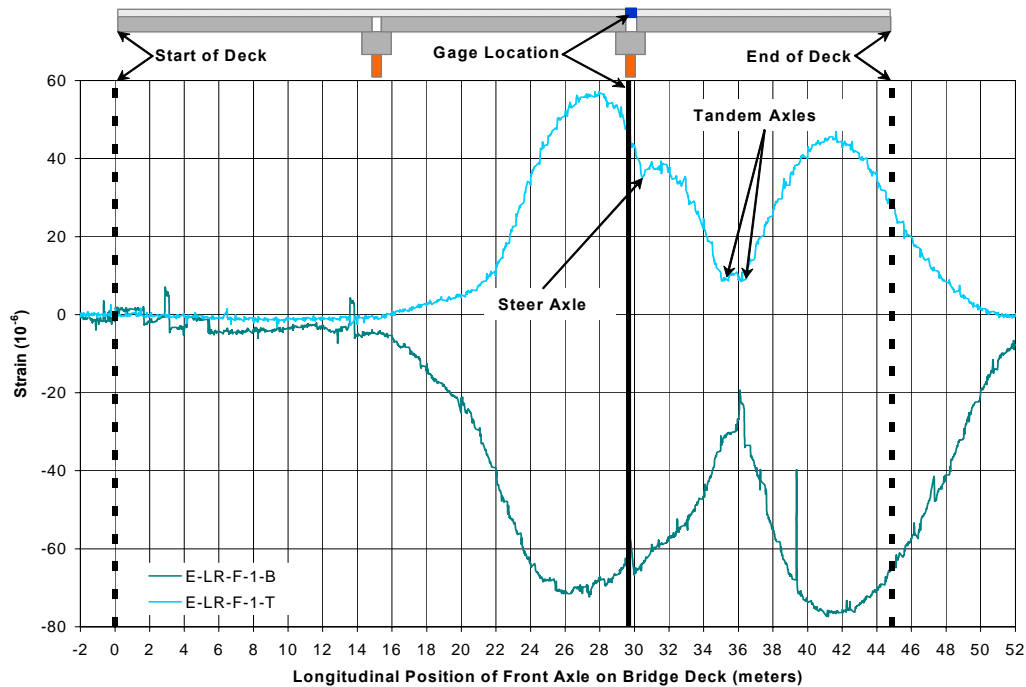
The accuracy of these differing responses was verified using co-located embedment gages. It is suggested that these differences in response are indicative of variations in the presence and restraint of longitudinal forces in each bridge. Despite the uniqueness of the specific response over the bent in each bridge, the recorded responses still verify that the expected behavior (i.e., negative bending moment) is present in each of the decks at magnitudes that are ‘reasonable’. All of the remaining longitudinal gages also show similar behavior among the three decks. This consistency in response further builds confidence in the accuracy of the data.

**Figure 40: Strain History - Empirical Deck Longitudinal Gage Location F-1 (ST-T Test)**

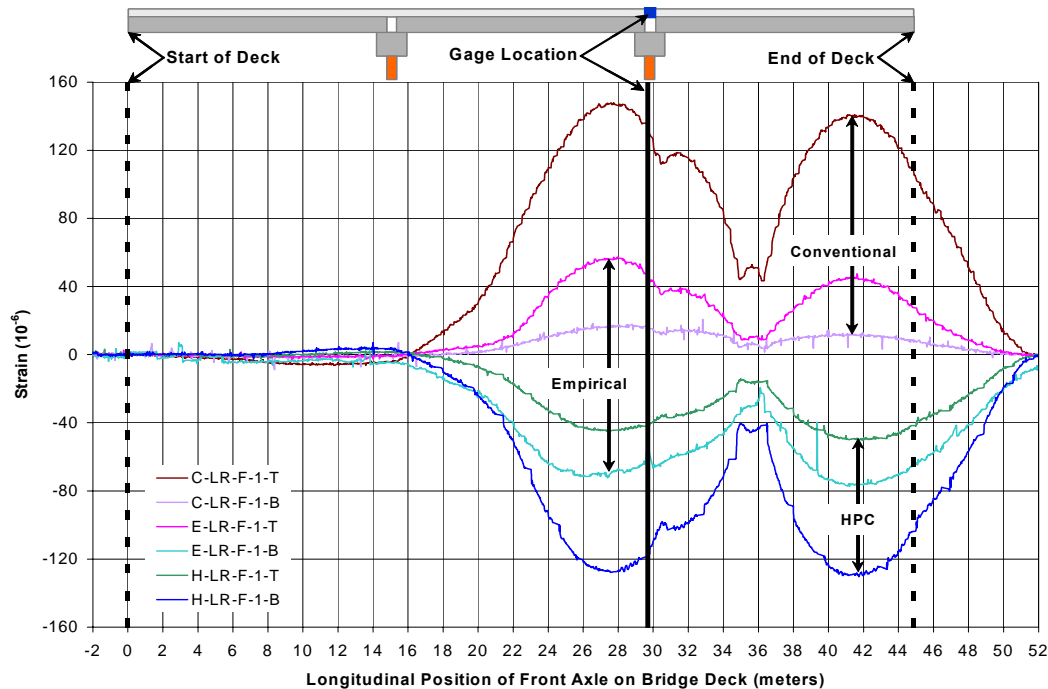
Strain histories in the transverse direction are the focus of the remainder of this analysis. The transverse gages were installed, conditioned, and recorded in the same manner as the longitudinal gages; thus, the corresponding strain histories should be valid. As observed for the longitudinal strains above, the measured transverse responses in all three bridges were generally similar in shape and magnitude under corresponding vehicle tests (several of these traces are presented and discussed in detail in the following sections of this report). These observations validate that it is reasonable to proceed with more complex analyses and begin drawing conclusions about deck behaviors from the data.

Figure 41: Strain history - all three decks longitudinal Gage Location F-1 (ST-T test)

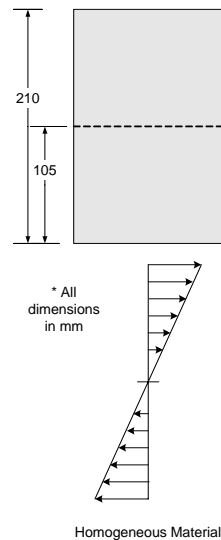
For composite materials such as reinforced concrete, the relative amount, location, and stiffness of the two materials each factor into the position of the bending neutral axis. The standard procedure used to locate the bending neutral axis is called the Method of Transformed Areas. This method converts the actual area of steel to a theoretical area of concrete that would provide equivalent flexural resistance. Thus, the ‘transformed’ cross-section is composed of a homogeneous material; and the location of the bending neutral axis can be determined by taking the first moments of area (Wang and Salmon, 1985).

**Figure 43: Homogeneous Deck Cross-Section Geometry with Calculated Bending Neutral Axis and Expected Bending Strain Profile (uncracked)**

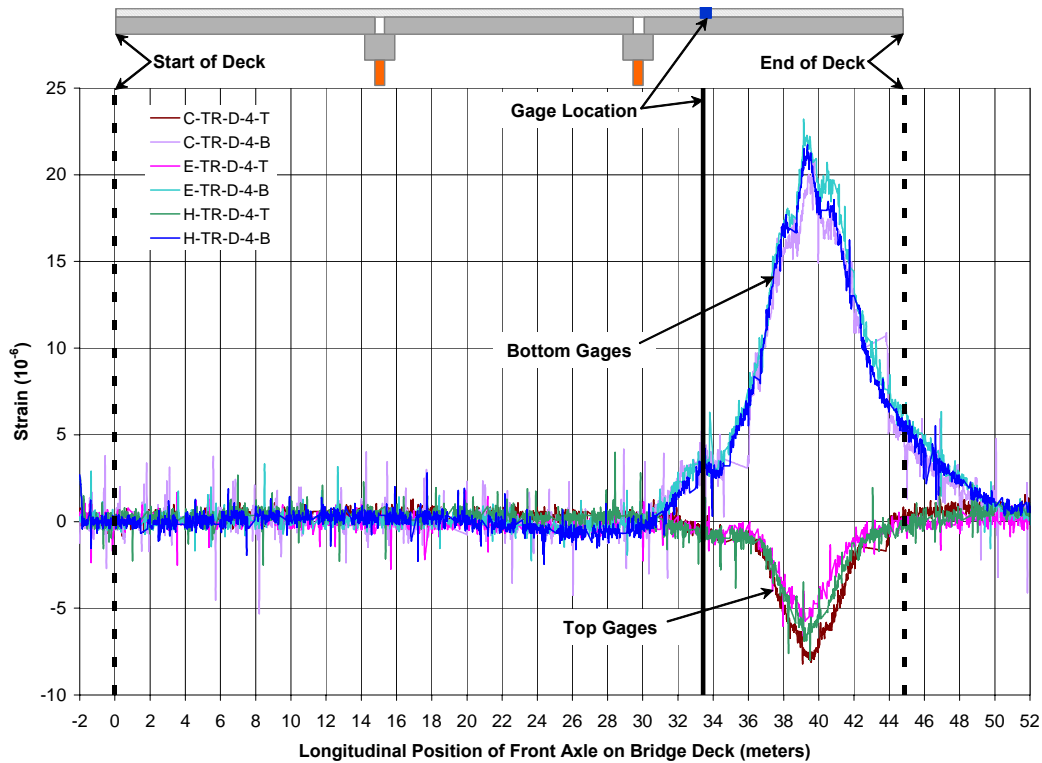
The location of the bending neutral axis in the bridge decks was determined using strain data recorded during live load testing. This neutral axis will be referred to as the **actual neutral axis** throughout the remainder of this report. Differences between the actual neutral axis and the predicted bending neutral axis are subsequently used in explaining deck behaviors observed under the live load events. Before looking at the specific neutral axis position, it is informative to review what these gages indicate relative to general behavior of the deck at this location during test ST-S. Loading from the ST-S live load test near the strain gages located at position D-4 produces a positive moment (top compression, bottom tension) in the deck, as expected. Strain histories generated from Gage Location D-4 during the ST-S test are shown in Figure 45 for all three bridge decks. Gages located in the bottom mat show tensile strains approximately twice as large in magnitude as the compressive strains in corresponding top gages, which is generally consistent with bottom-to-top strain ratios predicted above for pure bending in the decks (1.92:1, 1.94:1 and 1.82:1 for the and Conventional, HPC and Empirical decks, respectively). This general behavior is evident in all of the free-span areas under the influence of positive moments (i.e., it is not unique to Gage Location D-4). In addition, this behavior is also verified by strains reported from co-located concrete embedment gages at mid-depth and in the plane of the upper mat of reinforcing steel (not shown in Figure 45). Namely, in situations where positive moments are imparted by the test truck, tensile strains are recorded by gages located at mid-depth, which qualitatively supports the assertion that the actual neutral axis is nearer to the top mat of steel than to the bottom.

**Figure 45: Typical Positive Moment Response from Bonded Strain Gages (Gage Location D-4, ST-S Test)**

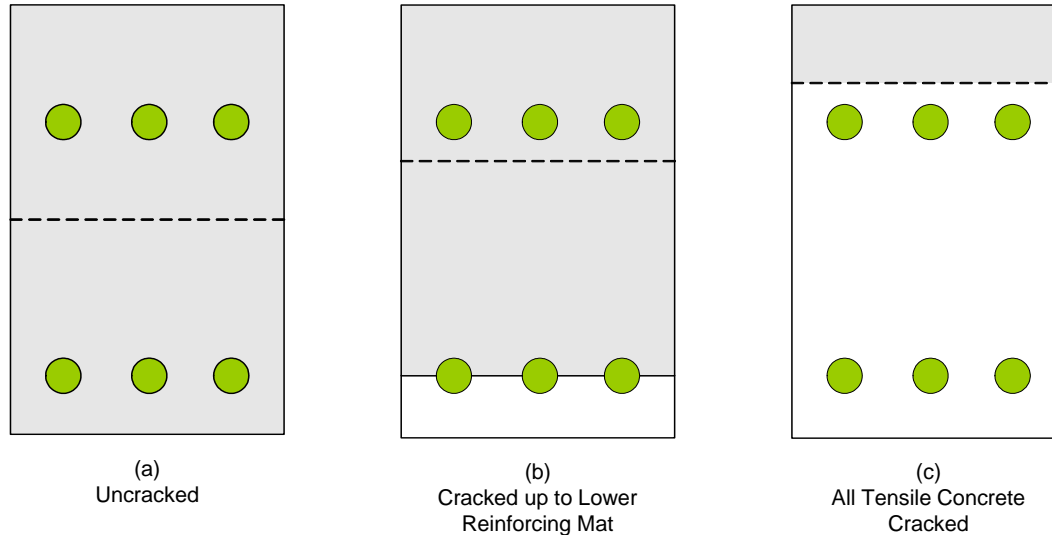
up to the lower mat of reinforcement, and all tensile concrete cracked. When the concrete cracks in the bottom fibers due to a positive moment, the cross-section geometry changes and the neutral axis is expected to shift upward in the cross-section. The heights of bending neutral axes for these three theoretical conditions in each of the bridge decks are provided in Table 12.

**Figure 48: Theoretical Cracking Scenarios**

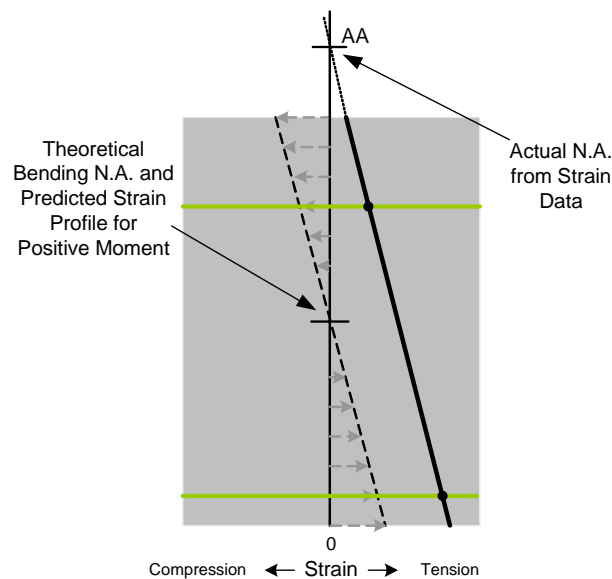
The net tension in the deck at Gage Location D-1 is obvious in the transverse strain profile recorded from all three bridges at 40 m (truck tires in the vicinity of Gage Line D) for test ST-S, as shown in Figure 51. The moments induced at Gage Location D-1 are relatively small, as indicated by small  $\phi$  angles. As such, bending and/or cracking effects are not expected to be very dramatic in this region. Therefore, it is reasonable to conclude that axial strains are predominantly governing the position of the actual neutral axis at Gage Location D-1.

**Figure 50: Illustration of Axial Tension Behavior at Gage Location D-1**

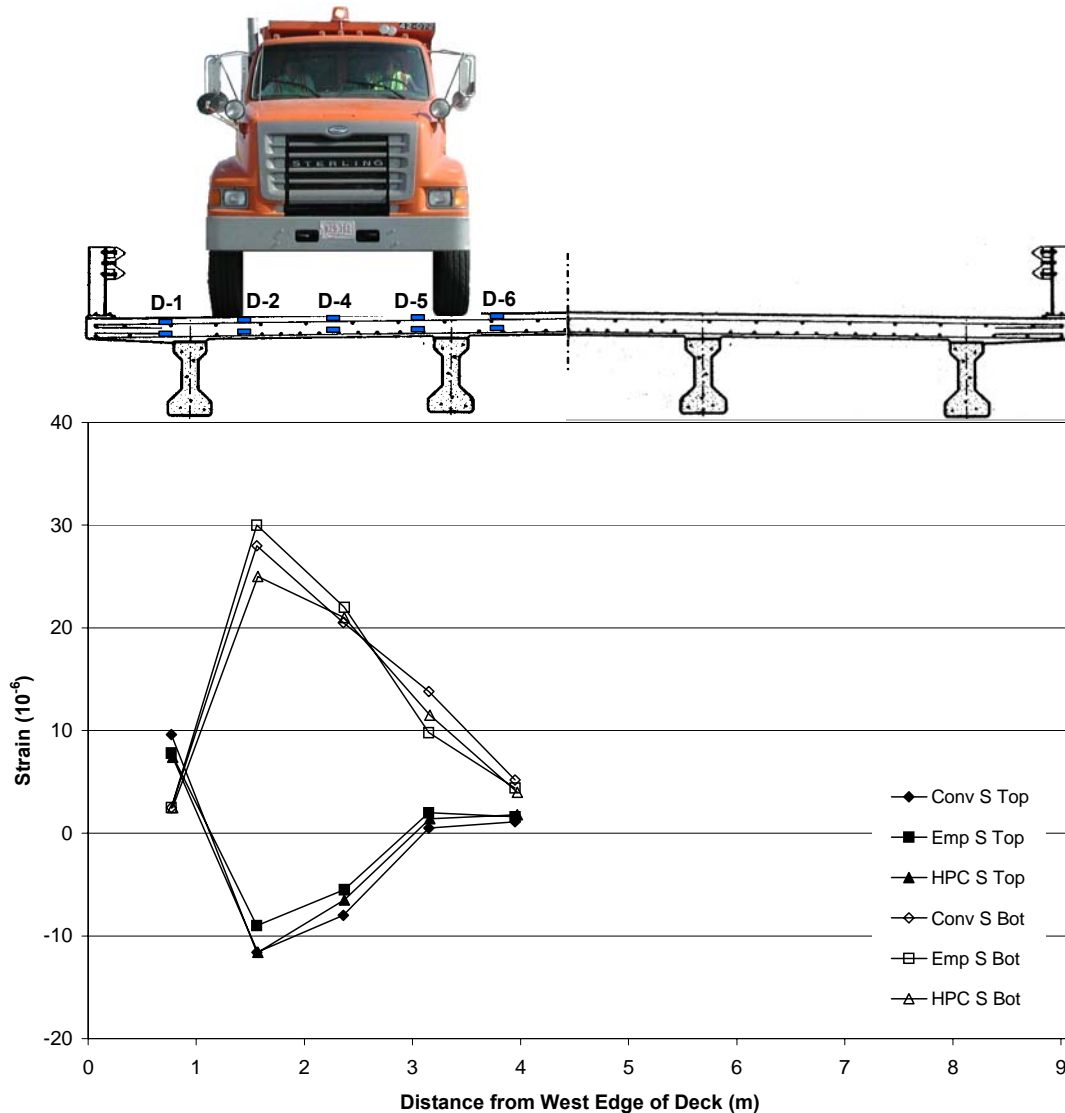
**Figure 51: Transverse Strain Profile Revealing Axial Tension (ST-S Test at 40 m Truck Position)**

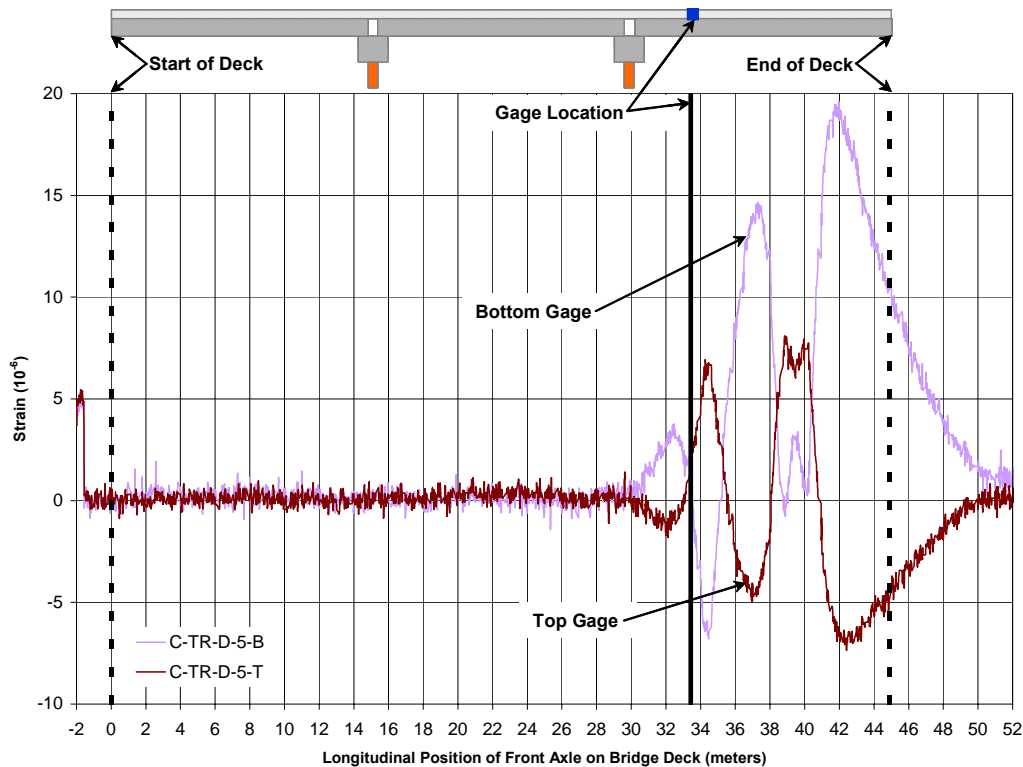
**Figure 52: Strain History at Gage Location D-5 during ST-U Test (Conventional Deck)**

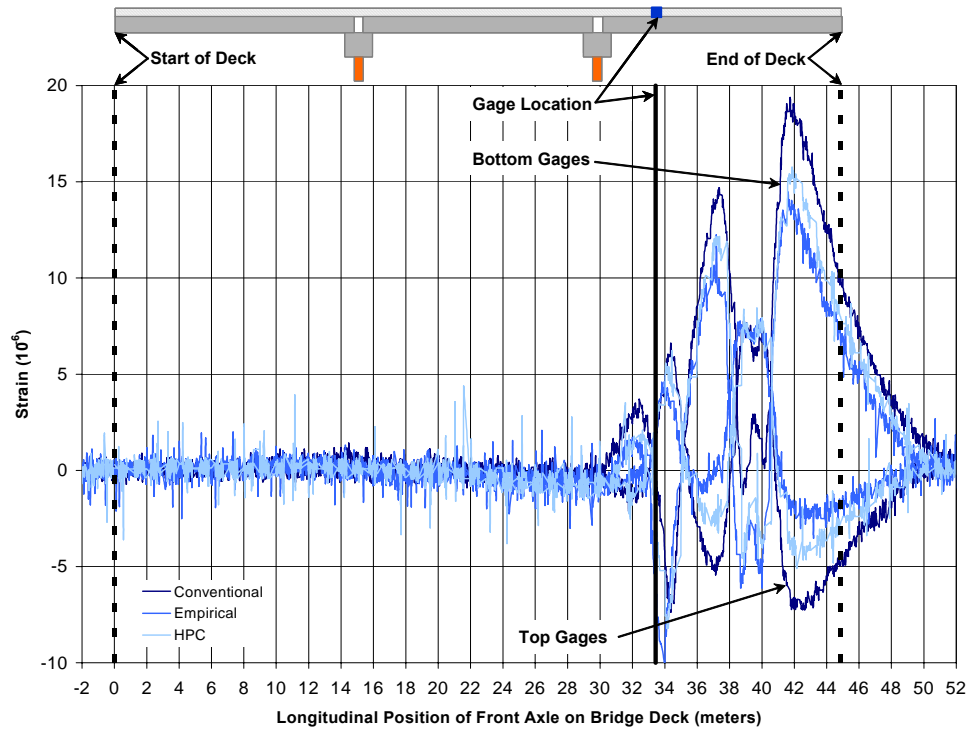
Nevertheless, referring to Figure 53, the maximum tensile strains in the top reinforcing steel in the decks during the negative moment response are less than  $10 \mu\epsilon$ . The corresponding tensile strains on the surface of the decks would be on the order of magnitude of approximately  $30 \mu\epsilon$ . This level of strain would not be expected to crack the decks, and there was no physical evidence of longitudinal cracks in the decks at this location immediately following the live load tests. Thus, this form of live load distress has not been as critical to deck performance as originally expected. This conclusion is not inconsistent with Cao's (1996) observation that negative moment effects are overstated in traditional design procedures because of the assumption that the girders act as rigid supports for the deck.

**Figure 53: Strain History at Gage Location D-5 during ST-U test (All Three Decks)**

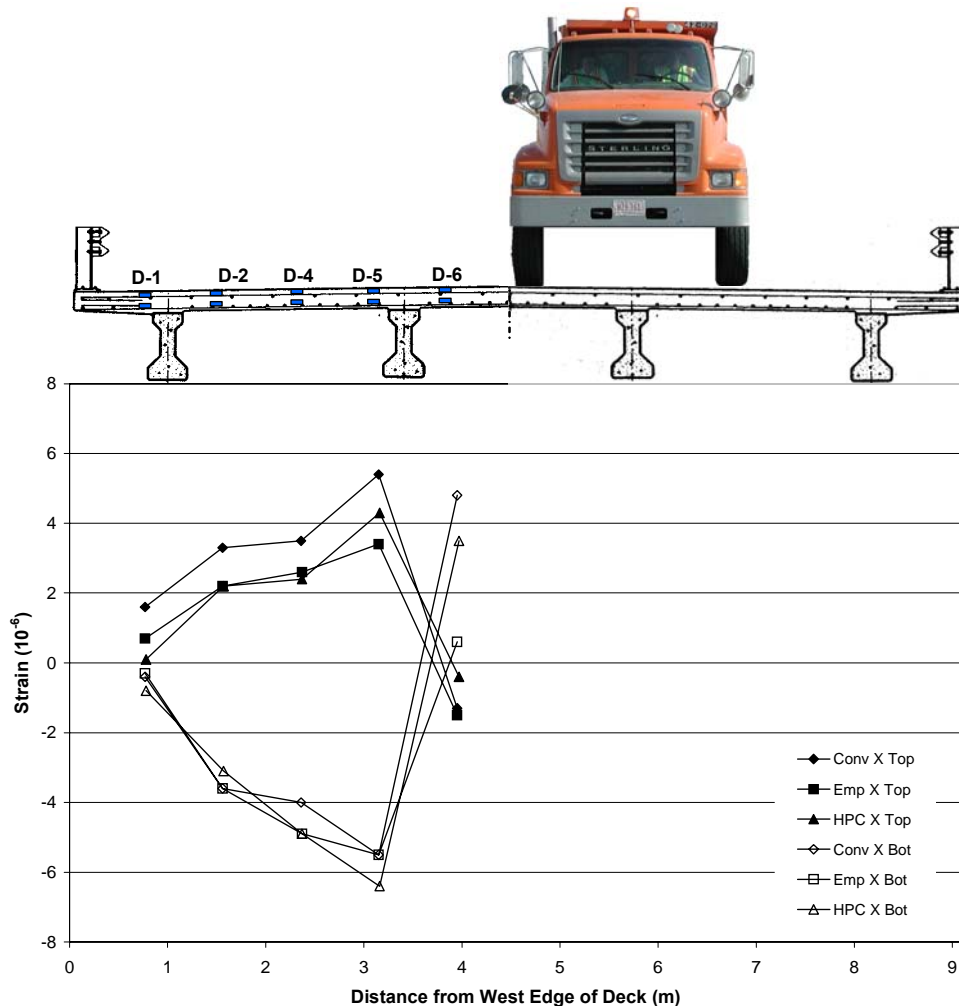
from the ST-Y and ST-Z tests. The tensile strains reported in Figure 55 are all below  $6 \mu\epsilon$ , which is well below the cracking strain of the concrete.

**Figure 55: Transverse Strain Profile Showing Tensile Shift under Negative Moment (ST-X Test at 40 m)**

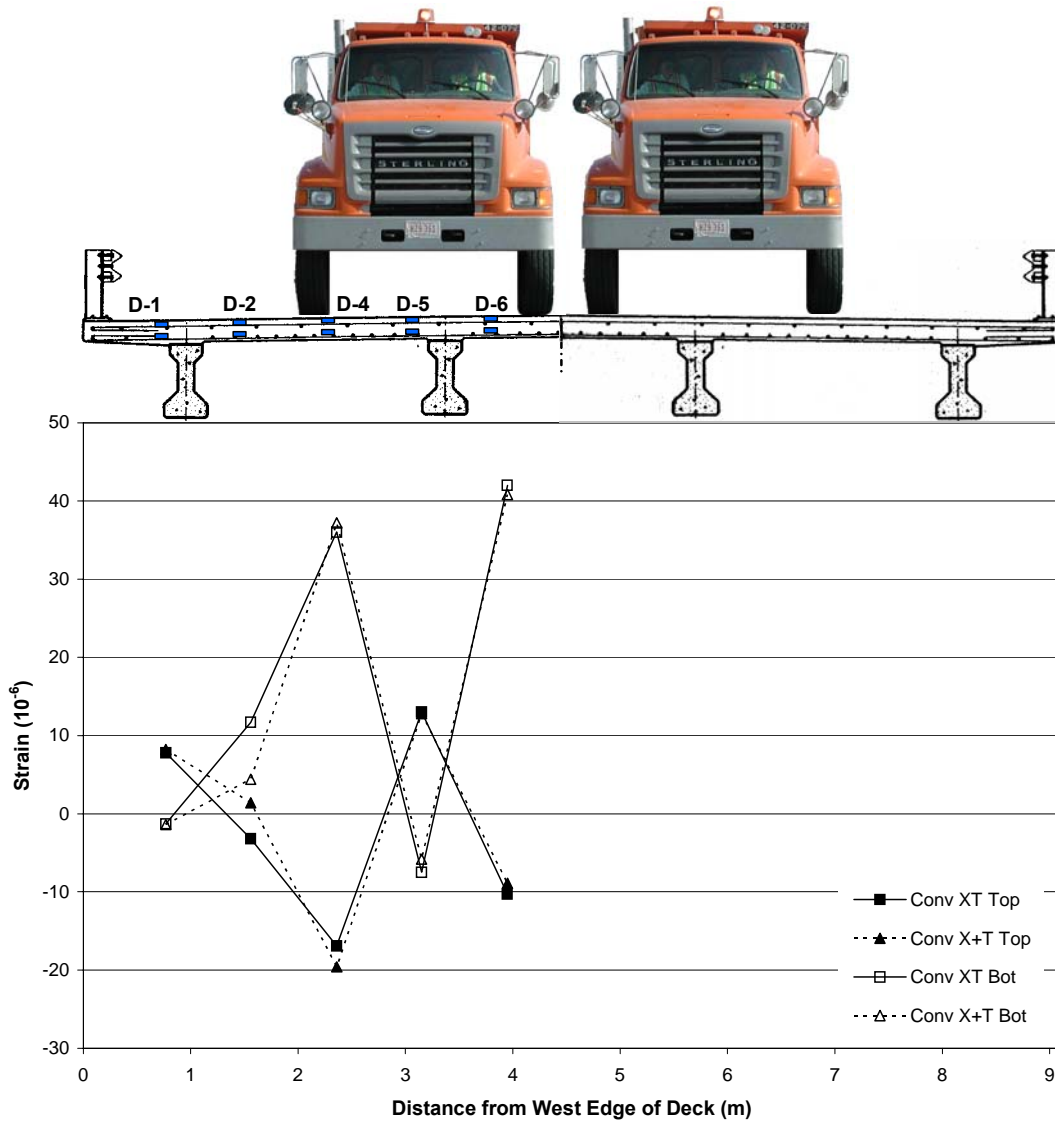
During live load testing, the three Saco bridges were tested using two heavily loaded three-axle dump trucks, traveling side-by-side along the length of the bridge, namely two-truck tests TT-WR and TT-XT (refer to Figure 36-b). Using superposition, strains measured during individual single-truck tests (ST-X and ST-T) were added together and the results compared to the strains measured during two-truck test (TT-XT) for the Conventional bridge deck at two truck positions, 40 m and 42 m. (Single truck test ST-W was not run, so superposition could not be directly evaluated for two truck test TT-WR.) Figures 58 and 59 compare the summed response from the separate single truck tests to the measured two-truck test response along Gage Line D for the Conventional deck at the 40 m and 42 m truck positions, respectively. With regard to shape and magnitude, the two transverse profiles look very similar overall, indicating superposition is valid. The greatest differences in strain magnitudes are observed at Gage Location D-2, but even these differences are nominal. It is unclear why differences at this location are larger than the other gage locations. Gage Location D-2 may be near the point of curvature reversal in the deck, and therefore be more sensitive to minor variations in the specific locations of the tires and/or the presence of an additional truck.

**Figure 58: Transverse Strain Profile Showing Superposition in the Conventional Deck from Gage Line D at the 40 m Truck Position**

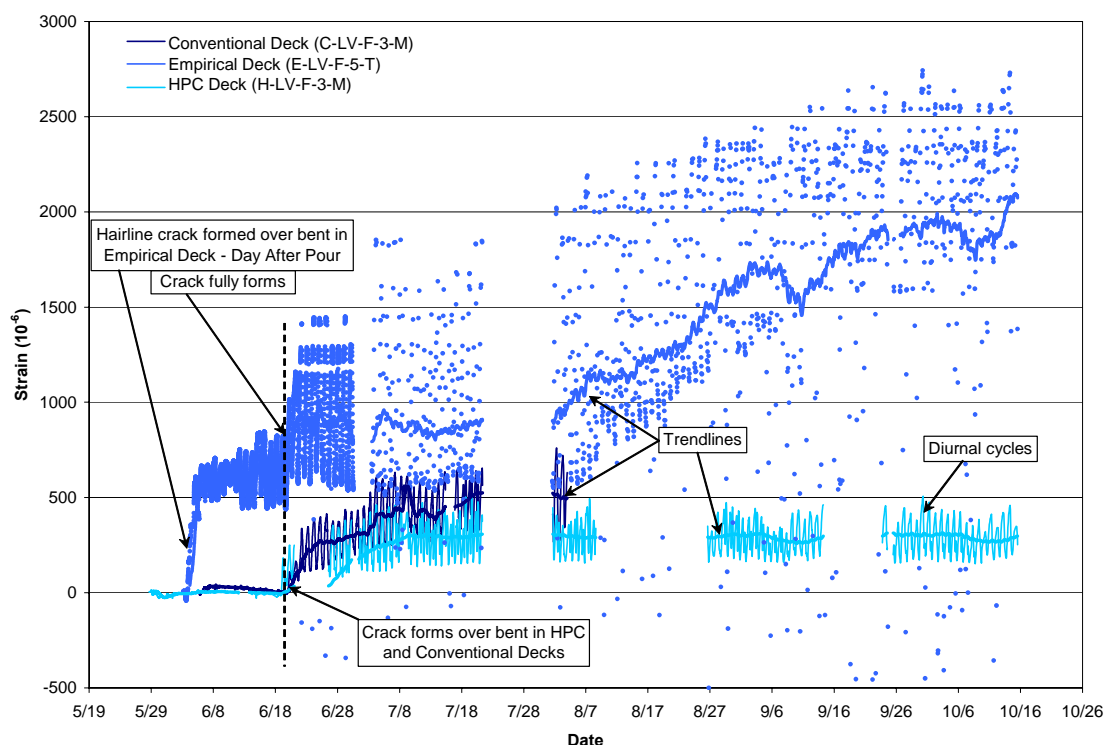
either formed or fully formed near June 19<sup>th</sup>. Further investigation into this matter may reveal the reason for this concurrent behavior.

**Figure 61: Long Term Data Showing the Formation of Cracks in All Three Decks.**

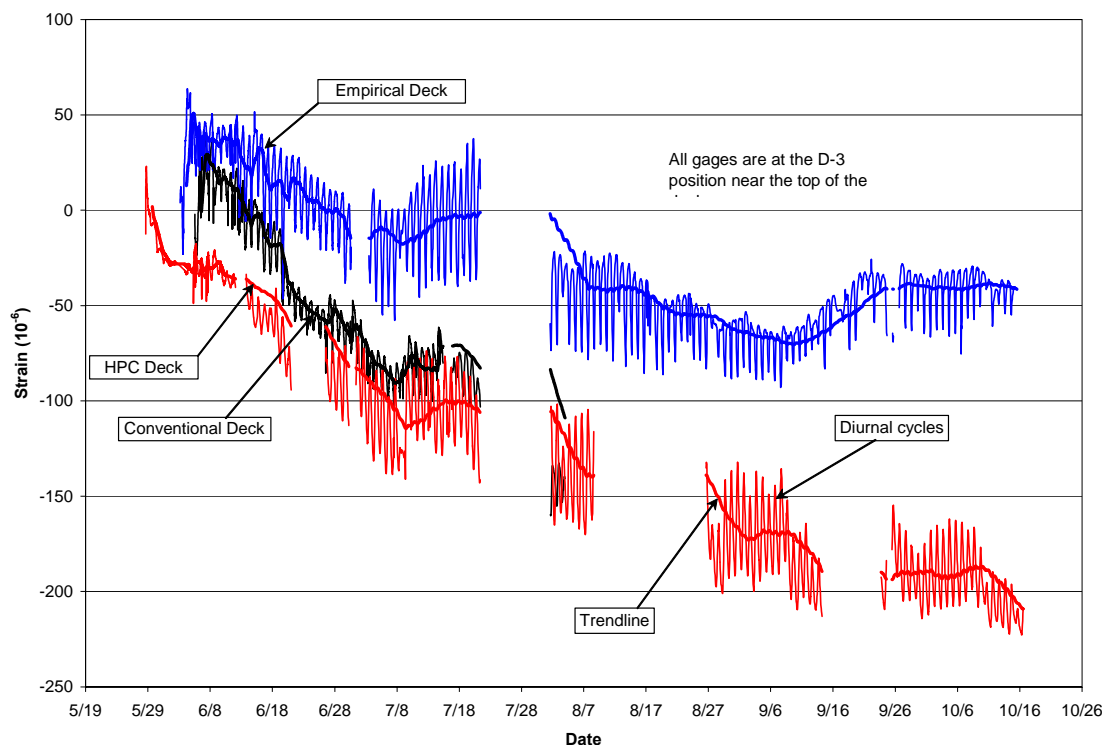
Unlike sensors spanning the bents, longitudinal sensors installed away from the bents (i.e., position D-3, halfway between the bents and the diaphragms and halfway between two girders) did not show that cracking had occurred. Figure 62 shows the response from vibrating wire strain gages near the top of the deck in each of the decks at this position. Diurnal strain fluctuations are small (approximately 20 to 70 $\mu\epsilon$ ), indicating contraction due to temperature changes and not cracks in the concrete.

**Figure 62: Long Term Data Illustrating Non-Cracked Portion of the Deck.**

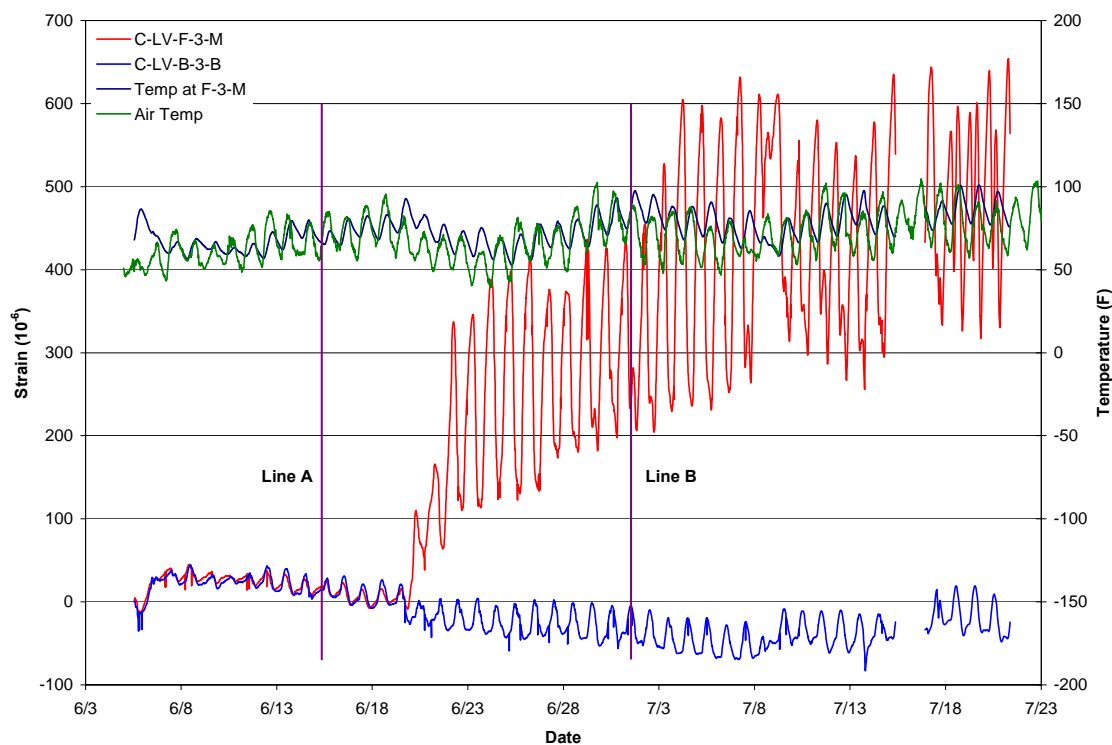
The formation and presence of a crack can clearly be seen in the data from the Conventional deck presented in Figure 63. In this case, longitudinal strains collected over the interior bent (Gage Location F-3) and over the intermediate diaphragm (Gage Location B-3) are compared. Prior to cracking, strains in these two locations are almost identical, simultaneously fluctuating based on daily temperature oscillations. Notably, prior to a crack formation, lower temperatures caused decreases in strain indicating thermal compression. Conversely, higher temperatures produced increases in strain (Line A, Figure 63).

**Figure 63: Comparison of Cracked and Non-cracked Position in the Conventional Deck.**
